Mobile Pentium® II Processor Specification Update

Release Date: February 2000

Order Number: 243887-018

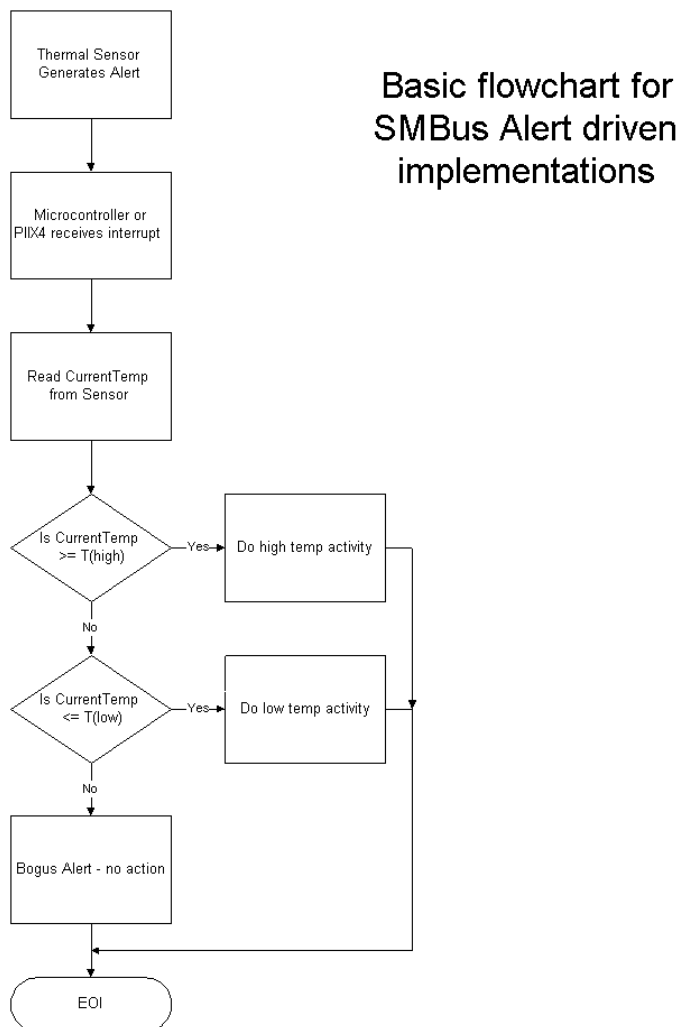
Figure 2. Workaround Flowchart: SMBALERT#-Driven System

Under the conditions described below, the thermal sensor incorrectly generates the SMBALERT# interrupt. All of the following conditions must be met to trigger a false interrupt:

1. Before servicing an interrupt from the thermal sensor, read and compare the processor thermal reading with the threshold limits (T_{HIGH} or T_{LOW}). Figures 2 and 3 provide basic flowcharts for the implementation of this workaround in an interrupt driven system.
2. If the firmware implemented polls the Status Register only, then before taking any action, re-read the temperature register and do a comparison with the alarm threshold limits (T_{HIGH} or T_{LOW}) to determine if the value is actually still within the temperature window.

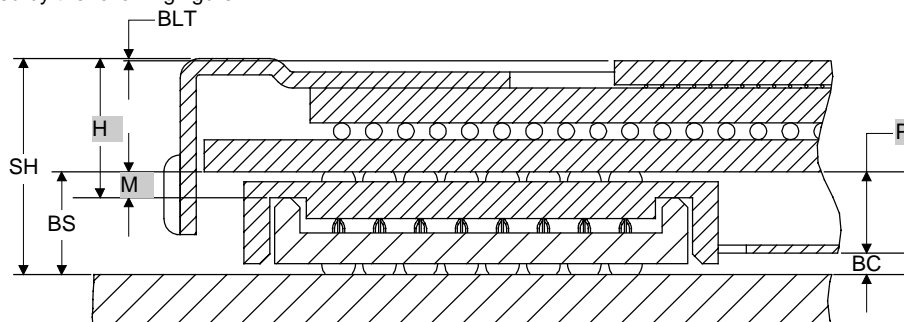
Figure 5.6. Cross Sectional View with Vertical Dimensions

B1. Misabeled Vertical Dimension Parameters

Figure 5.6 in the *Mobile Pentium® II Processor at 233 MHz, 266 MHz, and 300 MHz* datasheet should be replaced by the following figure:

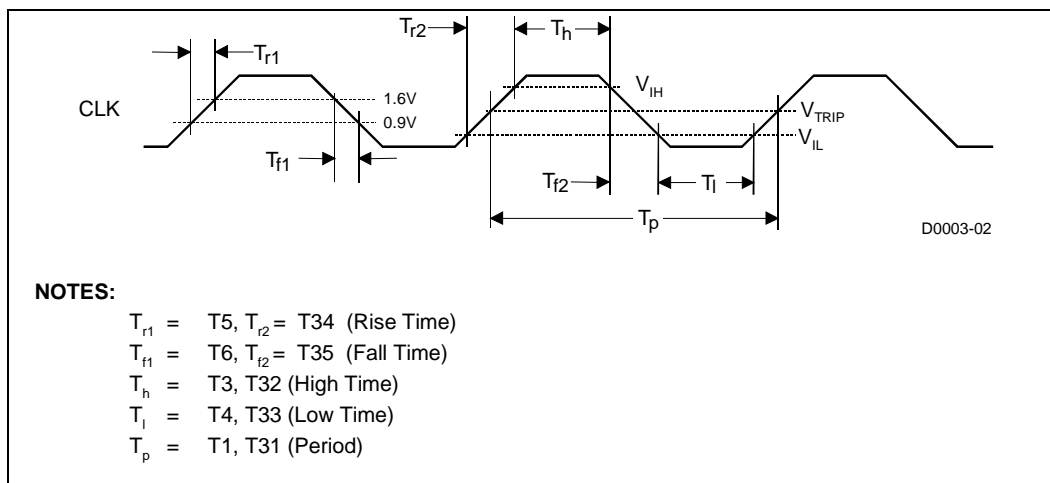
Figure 3.3 Generic Clock Waveform

B14. Generic Clock Waveform Figure

Figure 3.3 in *Mobile Pentium® II Processor in Mini-Cartridge Package at 366 MHz, 333 MHz, 300PE MHz, and 266PE MHz* datasheet (Order Number 245108), and the *Mobile Pentium® II Processor in BGA Package at 366 MHz, 333 MHz, 300PE MHz, and 266PE MHz* datasheet (Order Number 245106) has been updated. The following figure is to replace the ones in the above documents.

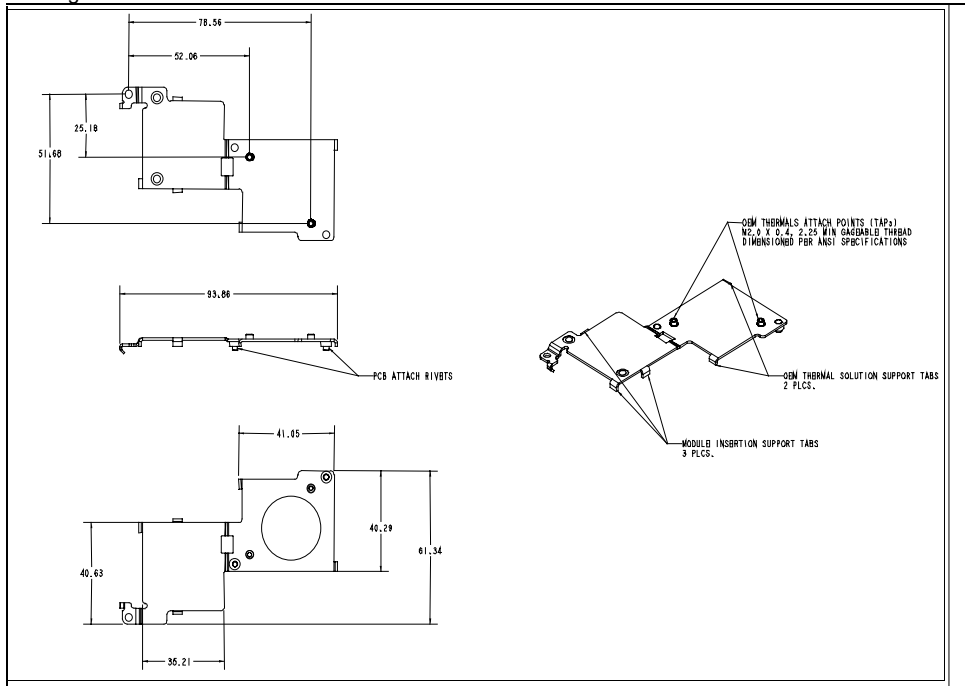
Figure 1. TAP Gageable Thread Clarification

OEM Thermal Attach Points (TAPs) M2.0 x 0.4, 2.25 min gageable thread dimensioned per ANSI specification.
